2479 Hella oem turn signal flasher relay short diagnosis and repair

Diagnosing the 2479 internal short

Disassembly and repair of the 2479 internal short

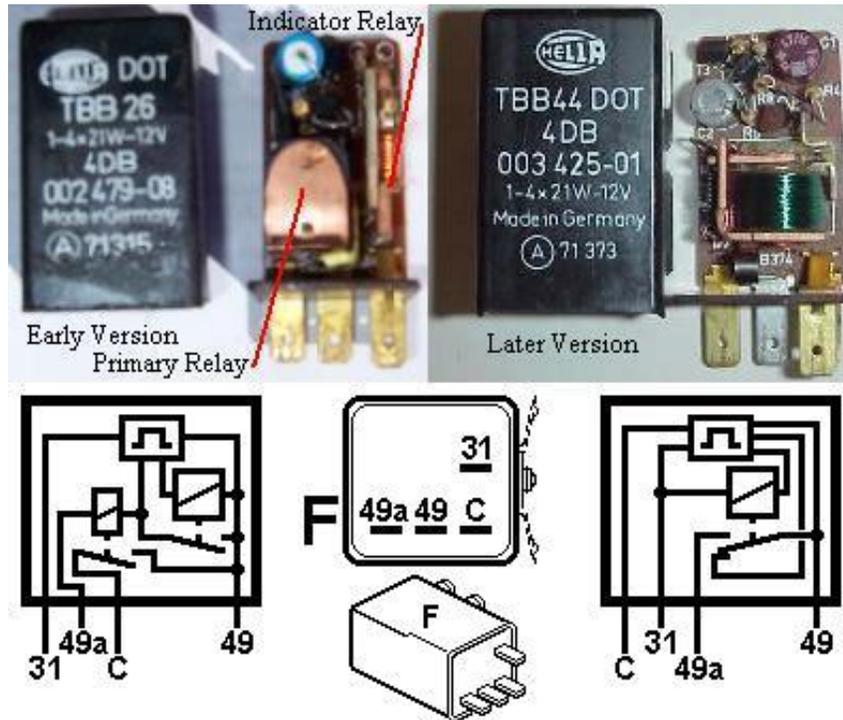
Early Hella 2479

current Hella 3425

The /6s were all supplied with the early Hella #2479. At some later date (1979?) the relay was updated to the currently available Hella relay #3425, BMW part #61 31 1 358 194. Both Hella relays have a “bulb out feature” which means when one of your bulbs is burned out (or you have a bad ground- which is very common on /6s) the remaining turn signal (on the burned out side) will continue to blink, but the dash indicator, will blink once, then stop.

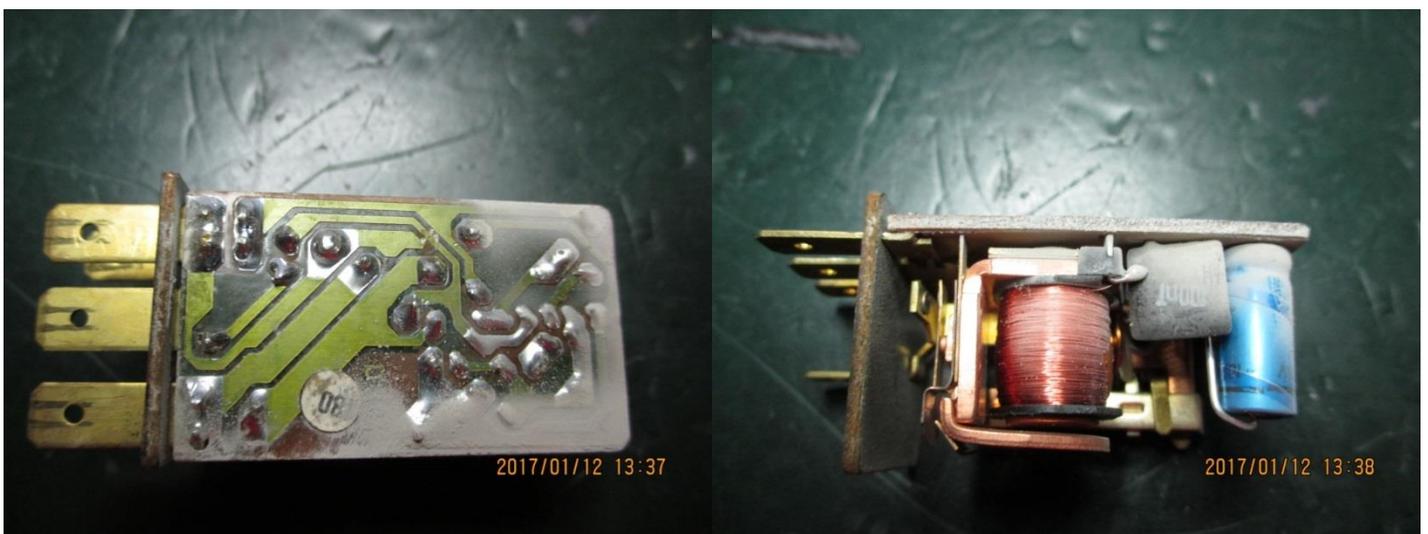
Remove the outer shell, and inspect interior. These photos show lots of grey (shorting) dust.

I disassembled the 2479 relay and found it to be a mess inside.

The PCB was covered with a fine gray dust that I assume is from the main flasher relay contacts spewing out particles over time. I flushed the PCB with acetone and used an acid brush, blew it out good and it cleaned up nicely. But (wait for it) the OEM pod lamp went from dim and got very bright! DOH! My guess is some of the gray dust got flushed even more into the relay problem area. I ohmed between C and 49 and got about 70 ohms.

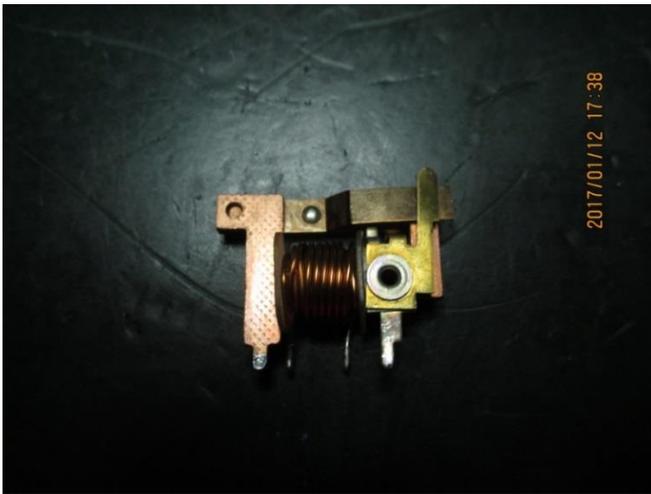
Indicator relay

For troubleshooting purposes I de-soldered and removed the indicator relay from the PCB and sure enough it was the culprit. I tried again to flush it and blow it out but no joy. See the photos below- It shows the relay edge on:

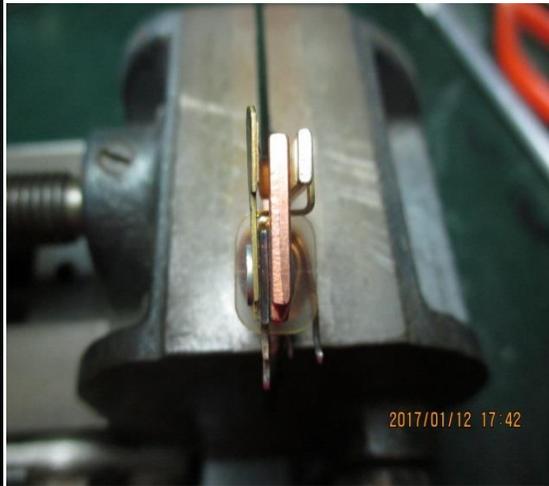
indicator relay edge on

The copper bar (relay frame) on the right is C and the black bar sandwiched in the middle with insulator pads on either side is 49. The dust shorting the two together is in that area. I re-soldered the relay to the PCB. It's easier to hold the PCB in a small machinist's vise for the next step.

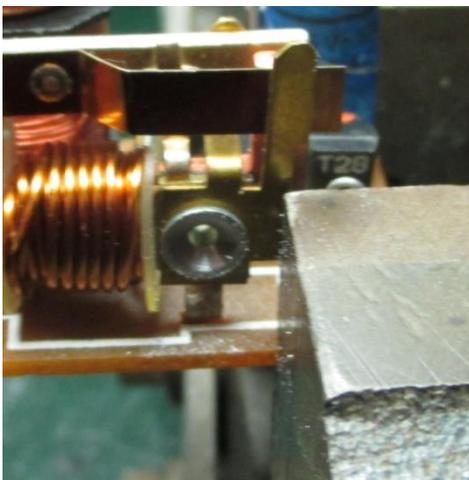
Rivet head drilling

Next I drilled off the rivet head fixing the relay contacts assembly, just to see where the dust settled into and couldn't be flushed out. As soon as the pressure from the rivet was removed the short circuit went away. No surprise there. I examined the contacts and didn't see any large build-up of the gray metallic dust that would have shorted out the contacts. The dust must have settled on the edges of the insulator pads.

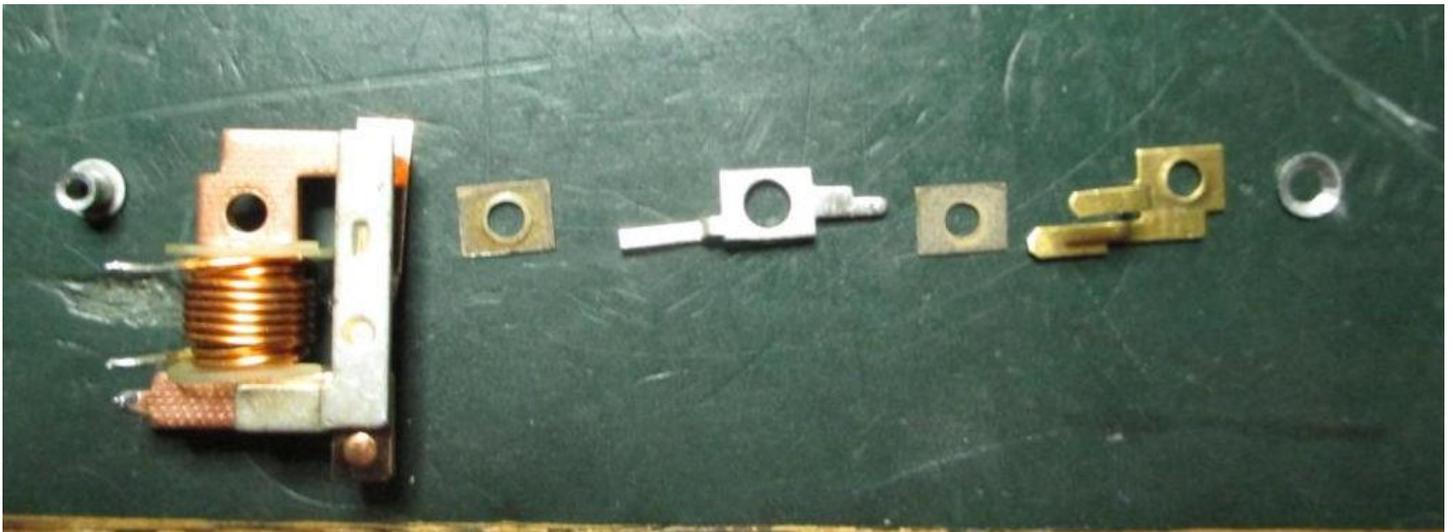
The indicator relay contact stack consists of the #49 (power) contact sandwiched between two di-electric insulator pads that are each only 0.015in thick. Over time the metal particles deposit on the edge of the insulator pads and provide a current path (not exactly a dead short) between #49 and #C (indicator lamp) of about 100 ohms or less. This current path allows the OEM pod turn signal lamp to glow dimly and the KATDASH LEDs to turn on brightly.

I wire brushed the metal parts of the contact stack and lightly scraped the edges of the insulator pads with an xacto blade. I reassembled the relay with a 4-40 button head screw, a small pattern nut and all relay functions work. I used a screw and nut in case I had to take it apart again. A 1/8in pop rivet would probably work also.

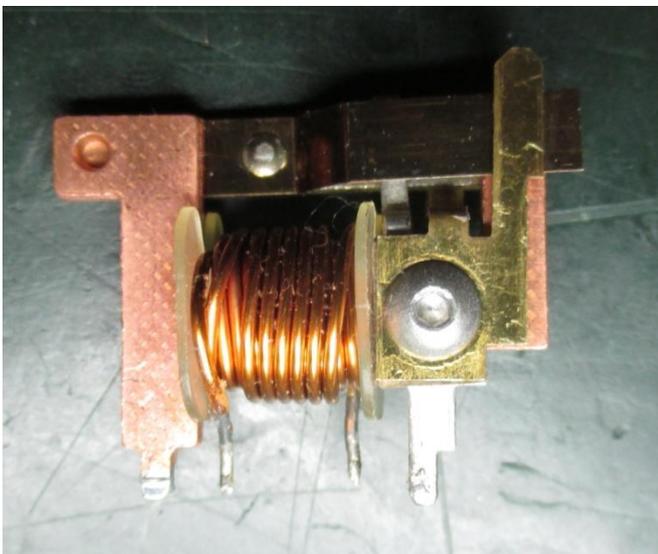
reassembled with 4-40 button head screw

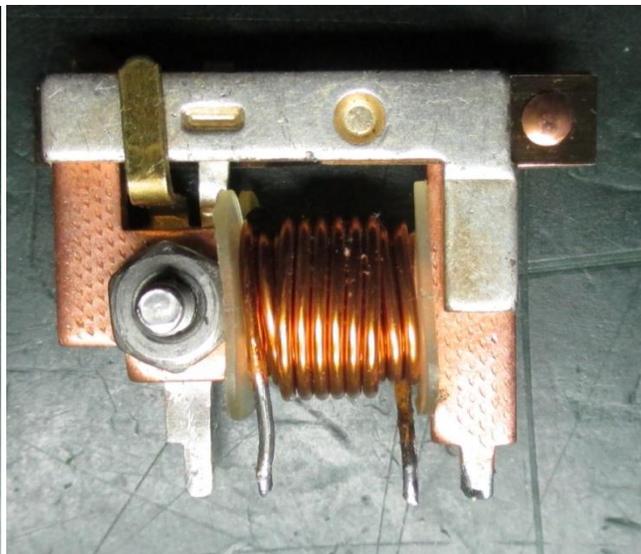
reassembled 4-40 small pattern nut
