2479 Hella oem turn signal flasher relay short diagnosis and repair

Diagnosing the 2479 internal short

Disassembly and repair of the 2479 internal short

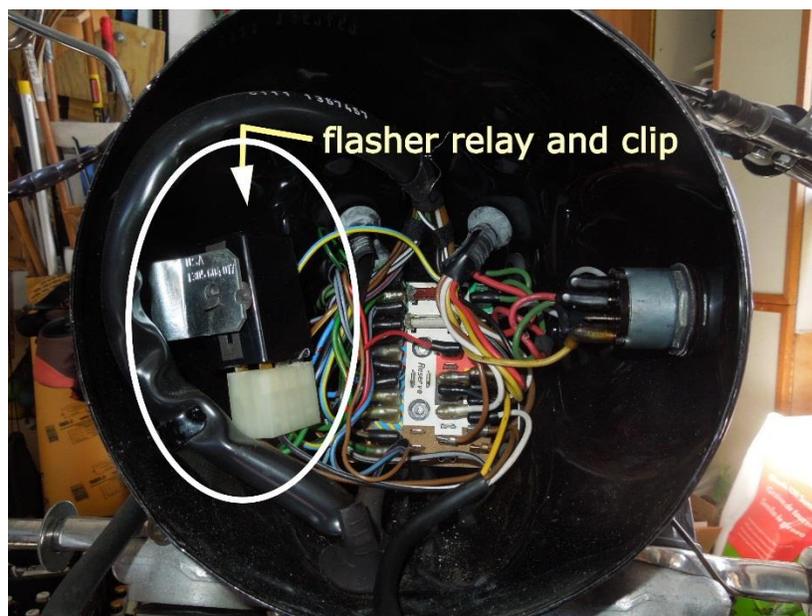
Disassembly procedure: notes and photos by Randy Tribe

I disassembled the 2479 relay and found it to be a mess inside.

In order to completely clean all of the “shorting dust” out of the contacts, repairing this relay will require you to drill off the rivet head, clean all the particulates from between the layers, then re-rivet, or use a 4-40 screw and small pattern nut. If you do not have the skill or the desire to go to this depth, then replace the turn signal relay.
